# Alpy 600 Removing IR-cut filter

Ref. DC0019A

### 1 Introduction

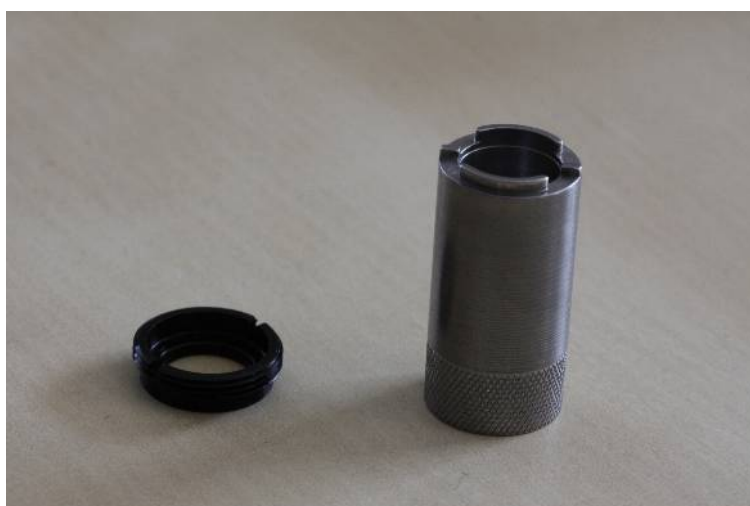
The kit contains the threaded ring and a tool (spanner wrench):

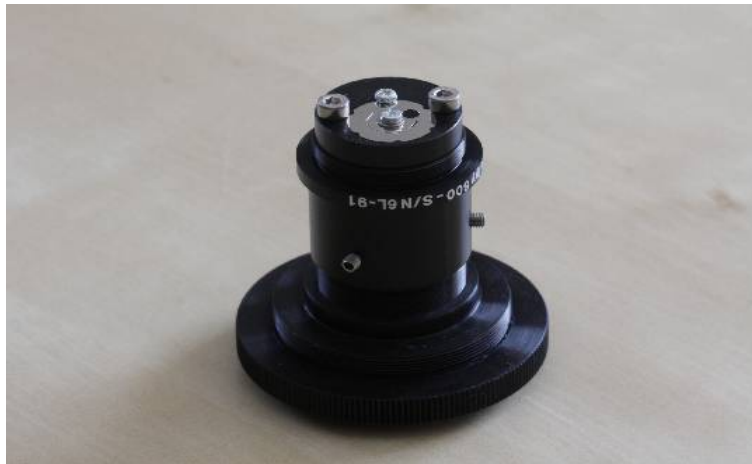
First, put the Alpy 600 on a table, like on this picture :

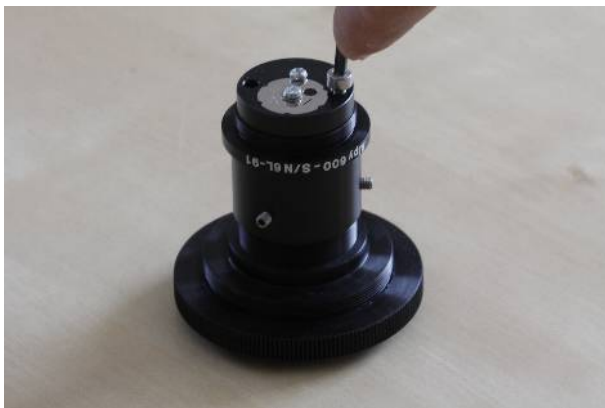
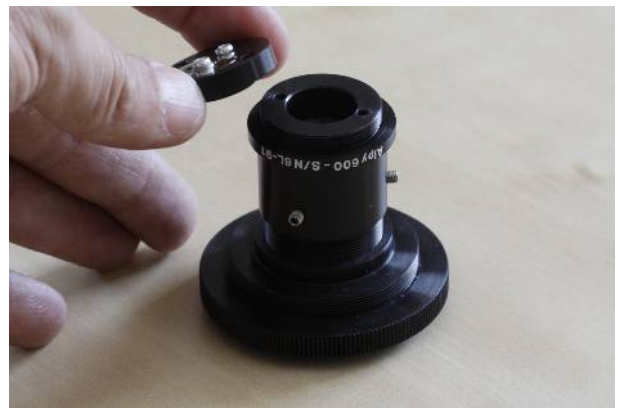
Remove the slit holder :

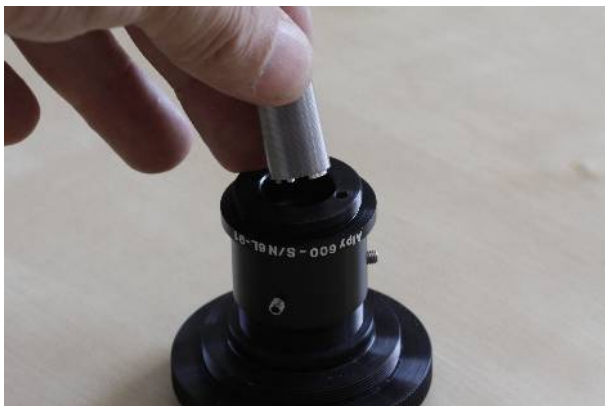
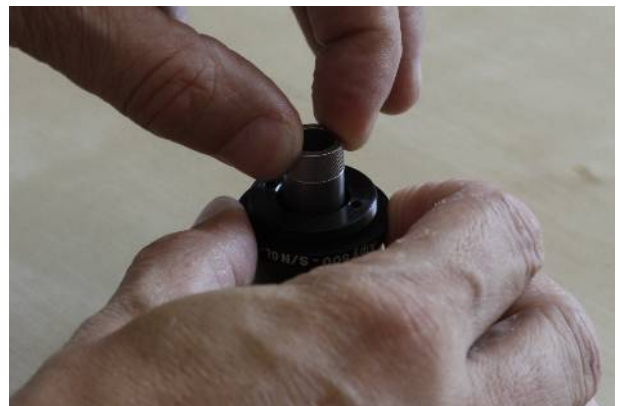
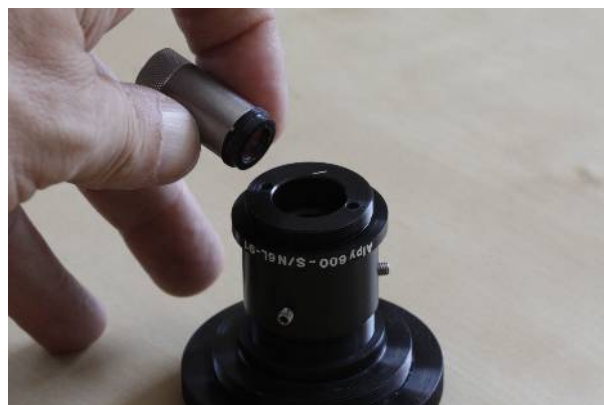
Remove the IR-cut filter ring with the spanner wrench :

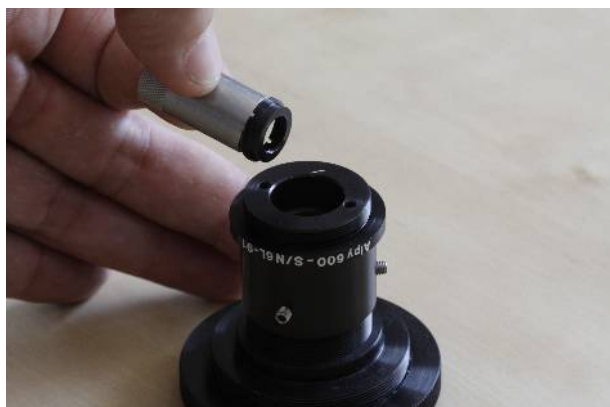
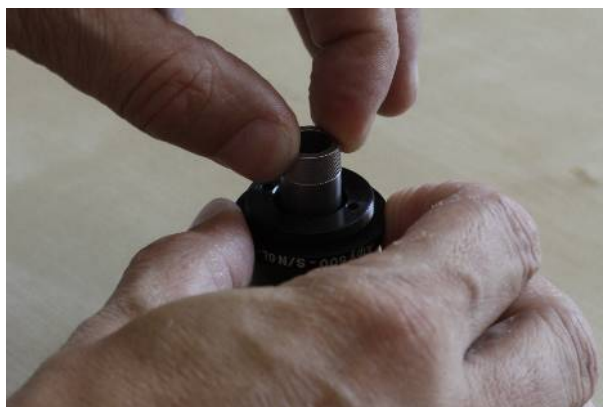
Take care to not return the assembly : the Alpy 600 collimator lens would fall down on the table.  
Replace the filter ring by the empty ring:

Tighten gently. Note that the ring is tightened against the Alpy 600 body - the collimator lens is under low pressure by a spring. There is no risk to damage the lens by tightening the ring.

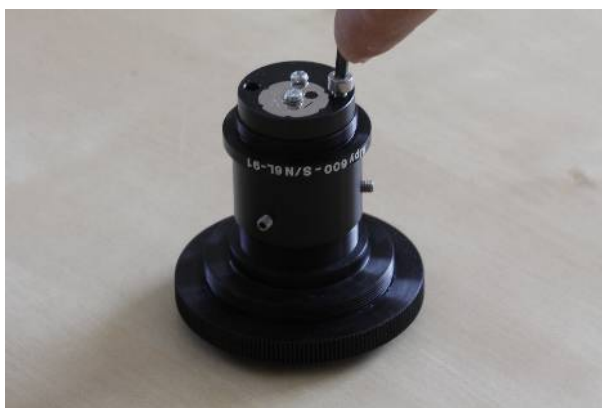
Mount back the slit holder :

The modification is done.
